REPORT

Order No.: 5933/3-I **Page 1 of 8 pages**
(Revised version of test report no. 5933/3 of 5 October 2016)

Purpose: Analysis of security envelopes for security mechanism

Sample designation	Sample description
PLASTSAFE Security Envelope	<p>Envelope material: LDPE-film</p> <p>Film thickness: 70 µm</p> <p>Side seam: heat-sealed seams</p> <p>Outside dimensions: approx. 195x295 mm</p> <p>Closure system: security tape (green/yellow, width: 35 mm)</p>

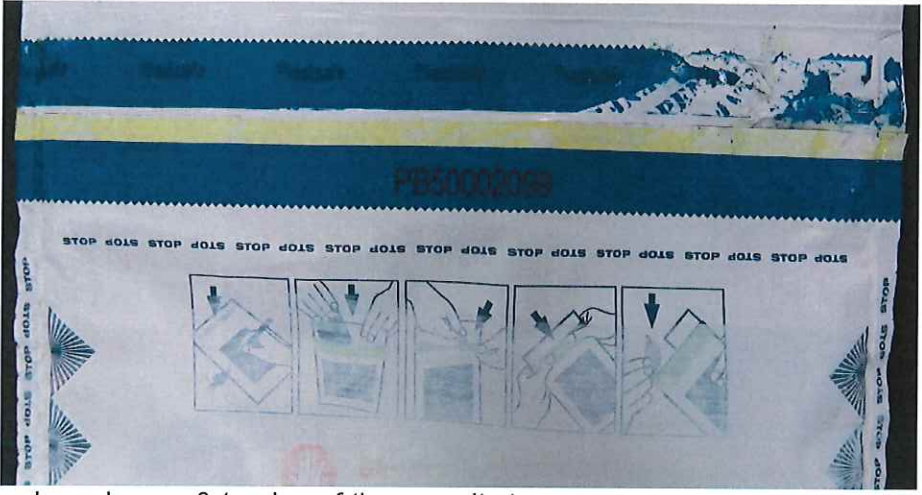
Solvent	Test result
Ethanol	<p>The security tape could be removed, but it was teared apart. The colour of the security tape changed from green to blue.</p> <p>The imprint of the bag's outer side was not removed, but could be wiped off.</p> <p>The side seams of the envelope could not be opened without destructing them.</p> <p>The test was performed on envelope no. PB50002099.</p> <div data-bbox="448 916 1374 1408">

<p>The image shows the same strip of security tape and envelope imprint after treatment with ethanol. The security tape is now blue and torn. The imprint is still visible but appears faded. The text 'PB50002099' is still visible on the tape.</p> </div> <p>colour change & tearing of the security tape</p>

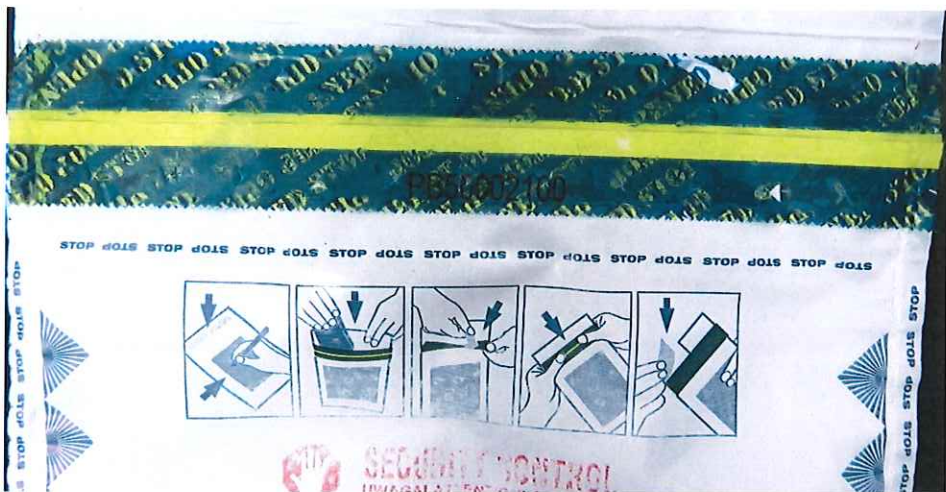
Solvent	Test result
Toluene	<p>The security tape could be removed. The words "OPENED/STOP" became repeatedly visible on the security tape and in the area of the security bag's opening.</p> <p>The imprint of the bag's outer side was not removed, but could be wiped off.</p> <p>The side seams of the envelope could not be opened without destructing them.</p> <p>The test was performed on envelope no. PB50002100.</p> <div data-bbox="448 524 1374 1014">

<p>appearance of "OPENED/STOP" - security sign</p> </div>

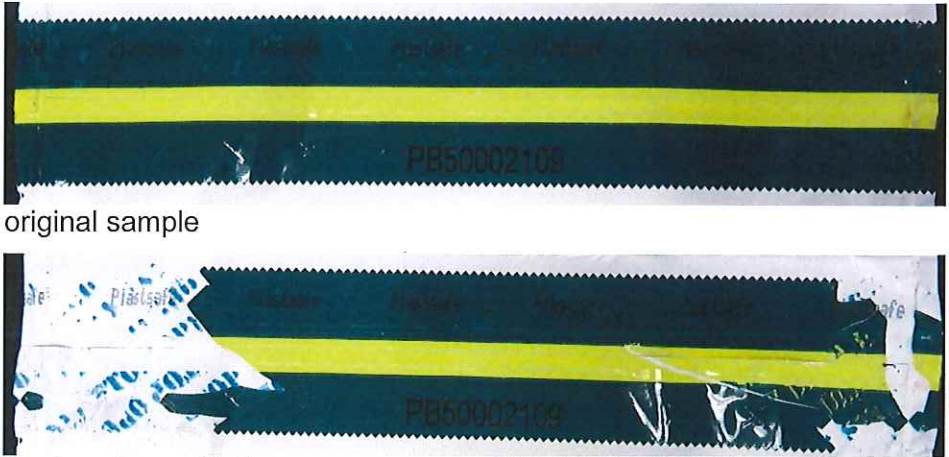
Temperature	Test result
Room temperature (23 °C)	<p>The security tape could not be removed without destructing it. During the manipulation attempt the words "OPENED/STOP" became partly visible on the security tape and in the area of the security bag's opening. The test was performed on envelope no. PB50002109.</p>

<p>original sample</p> <p>tearing of security tape, appearance of "OPENED/STOP" security sign</p>

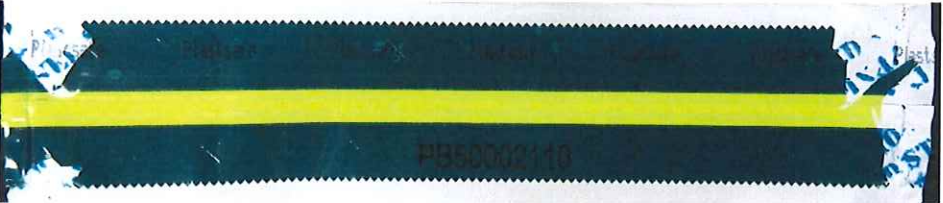
Temperature	Test result
<p>- 20 °C</p>	<p>The security tape could not be removed without destructing it. During the manipulation attempt the words "OPENED/STOP" became partly visible on the security tape and in the area of the security bag's opening. The test was performed on envelope no. PB50002110.</p>

<p>tearing of security tape, appearance of "OPENED/STOP" security sign</p>
<p>Immediate Freezing (- 40 °C)</p>	<p>The security tape could not be removed without destructing it. During the manipulation attempt the words "OPENED/STOP" became partly visible on the security tape and in the area of the security bag's opening. The test was performed on envelope no. PB50002111.</p>

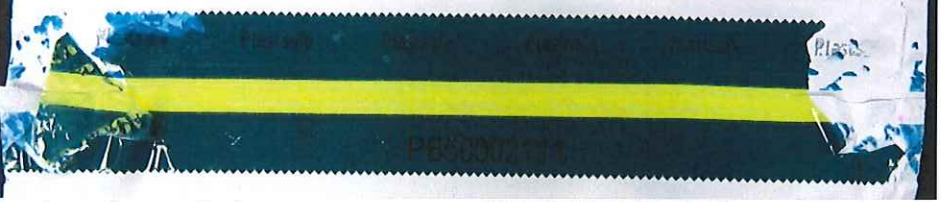
<p>tearing of security tape, appearance of "OPENED/STOP" security sign</p>

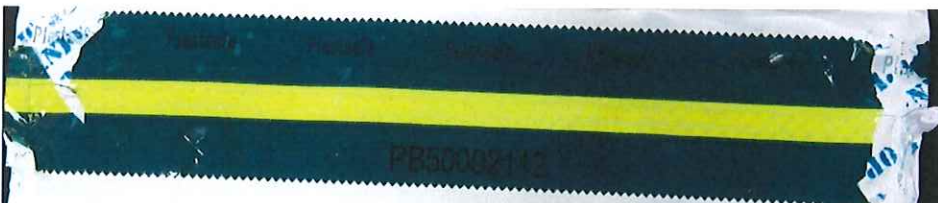
Temperature	Test result
60 °C	<p>The security tape could not be removed without destructing it. During the manipulation attempt the words "OPENED/STOP" became partly visible on the security tape and in the area of the security bag's opening. The heat indicator showed an irreversible red dyeing. The test was performed on envelope no. PB50002112.</p>

<p>tearing of security tape, appearance of "OPENED/STOP" security sign, colour change of heat indicator</p>
105 °C	<p>The security tape could not be removed without destructing it. During the manipulation attempt the words "OPENED/STOP" became partly visible on the security tape and in the area of the security bag's opening. The heat indicator showed an irreversible red dyeing. The test was performed on envelope no. PB50002113.</p>

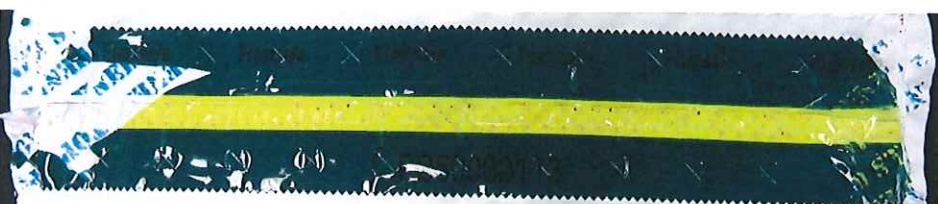
<p>tearing of security tape, appearance of "OPENED/STOP" security sign, colour change of heat indicator</p>
