REPORT

Order No.: 5933/3-I **Page 1 of 8 pages**
(Revised version of test report no. 5933/3 of 5 October 2016)

Purpose: Analysis of security envelopes for security mechanism

Sample designation	Sample description
PLASTSAFE Security Envelope	<p>Envelope material: LDPE-film</p> <p>Film thickness: 70 µm</p> <p>Side seam: heat-sealed seams</p> <p>Outside dimensions: approx. 195x295 mm</p> <p>Closure system: security tape (green/yellow, width: 35 mm)</p>

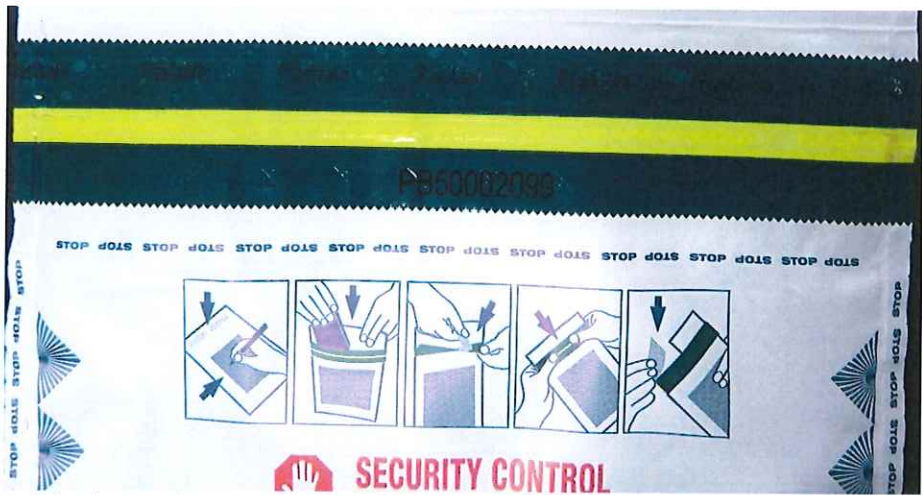
Solvent	Test result
Ethanol	<p>The security tape could be removed, but it was teared apart. The colour of the security tape changed from green to blue.</p> <p>The imprint of the bag's outer side was not removed, but could be wiped off.</p> <p>The side seams of the envelope could not be opened without destructing them.</p> <p>The test was performed on envelope no. PB50002099.</p> <div data-bbox="448 916 1374 1408">

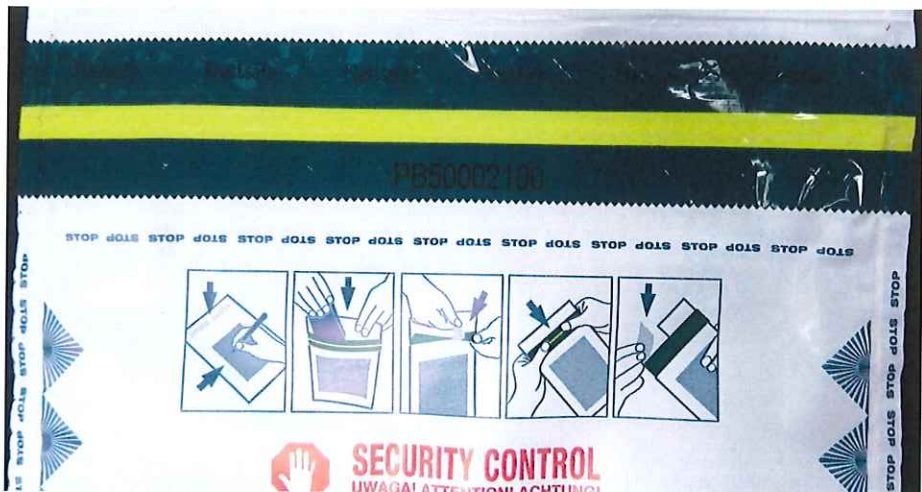
Solvent	Test result
Toluene	<p>The security tape could be removed. The words "OPENED/STOP" became repeatedly visible on the security tape and in the area of the security bag's opening.</p> <p>The imprint of the bag's outer side was not removed, but could be wiped off.</p> <p>The side seams of the envelope could not be opened without destructing them.</p> <p>The test was performed on envelope no. PB50002100.</p> <div data-bbox="448 524 1374 1014">

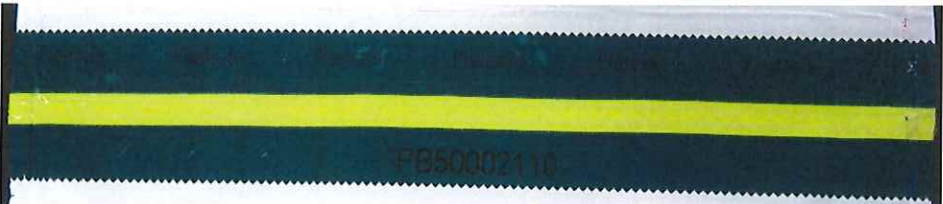
Temperature	Test result
<p>- 20 °C</p>	<p>The security tape could not be removed without destructing it. During the manipulation attempt the words "OPENED/STOP" became partly visible on the security tape and in the area of the security bag's opening. The test was performed on envelope no. PB50002110.</p>

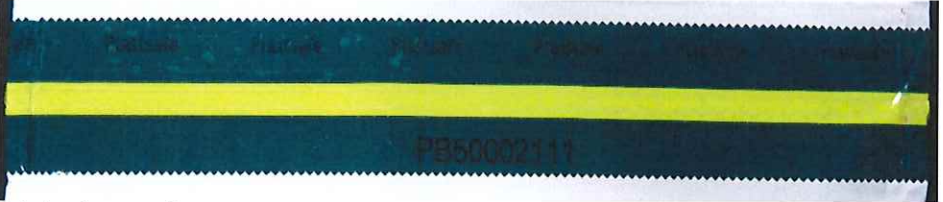
<p>tearing of security tape, appearance of "OPENED/STOP" security sign</p>
<p>Immediate Freezing (- 40 °C)</p>	<p>The security tape could not be removed without destructing it. During the manipulation attempt the words "OPENED/STOP" became partly visible on the security tape and in the area of the security bag's opening. The test was performed on envelope no. PB50002111.</p>

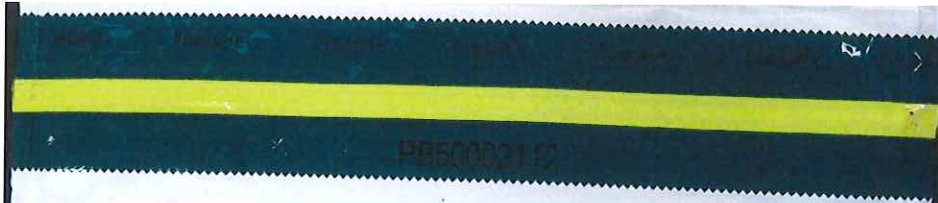
Temperature	Test result
60 °C	<p>The security tape could not be removed without destructing it. During the manipulation attempt the words "OPENED/STOP" became partly visible on the security tape and in the area of the security bag's opening. The heat indicator showed an irreversible red dyeing. The test was performed on envelope no. PB50002112.</p>

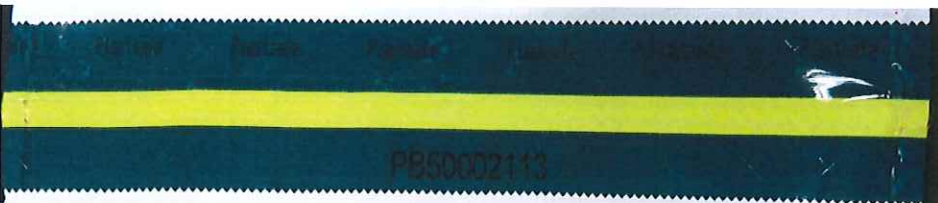
<p>tearing of security tape, appearance of "OPENED/STOP" security sign, colour change of heat indicator</p>
105 °C	<p>The security tape could not be removed without destructing it. During the manipulation attempt the words "OPENED/STOP" became partly visible on the security tape and in the area of the security bag's opening. The heat indicator showed an irreversible red dyeing. The test was performed on envelope no. PB50002113.</p>
